NDI ID PA 00571

HEMLOCK LAKE DAM

PHASE I INSPECTION REPORT
NATIONAL DAM INSPECTION PROGRAM

APRIL 1981

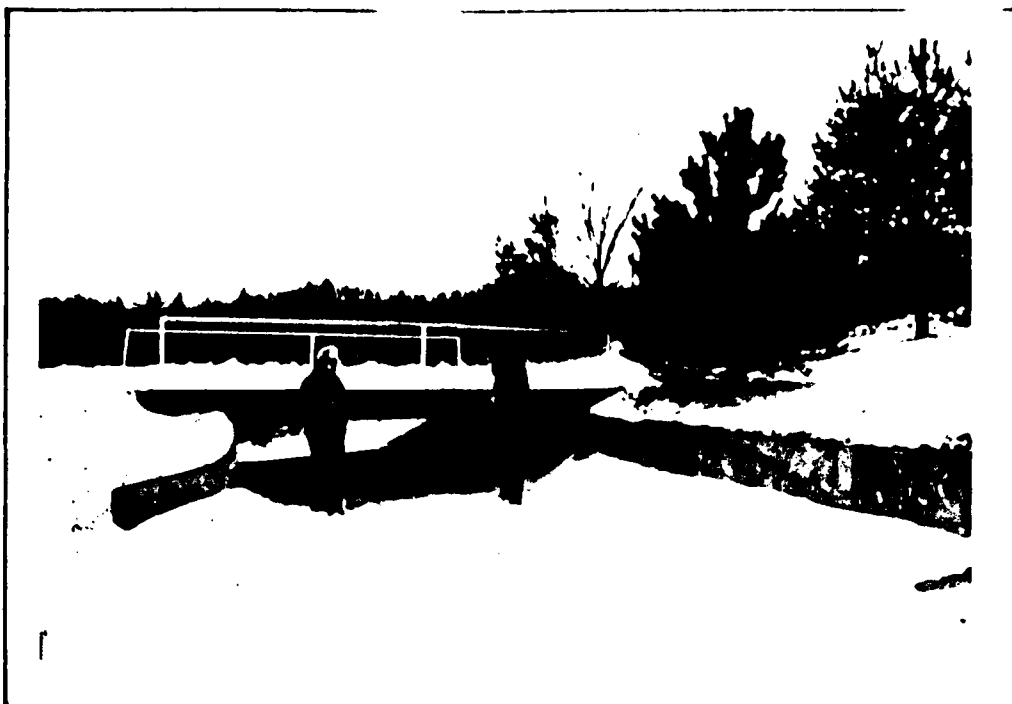
c. Appurtenant Structures. The rectangularly shaped concrete spillway is located at the right abutment. Most of the concrete appears to be in good condition, with some minor spalling noted on the right training wall of the approach section. No settlement was observed in the spillway.

3. LOOKING DOWNSTREAM AT THE SPILLWAY ENTRANCE CHANNEL.
(12/20/80)

10. Repair minor spalling of concrete on the approach channel walls of the spillway.

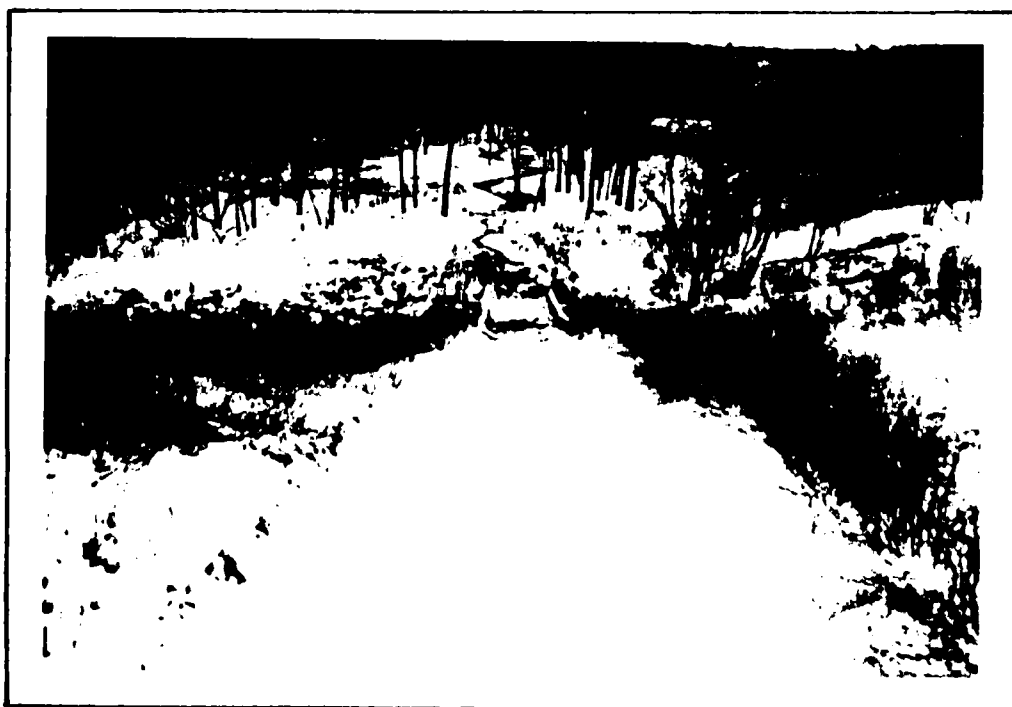
on March 12, 1981, seepage (1 gpm) was observed discharging from a joint on the right side of the spillway discharge chute about 30 feet downstream of the control section of the spillway. No settlement of the individual concrete sections of the chute were noted.

4. LOOKING DOWNSTREAM AT THE SPILLWAY EXIT CHANNEL.

8. Provisions should be made for the emergency closure of the upstream end of the outlet pipe.
9. The adequacy of the energy dissipator at the downstream end of the spillway chute during high discharge conditions should be evaluated.

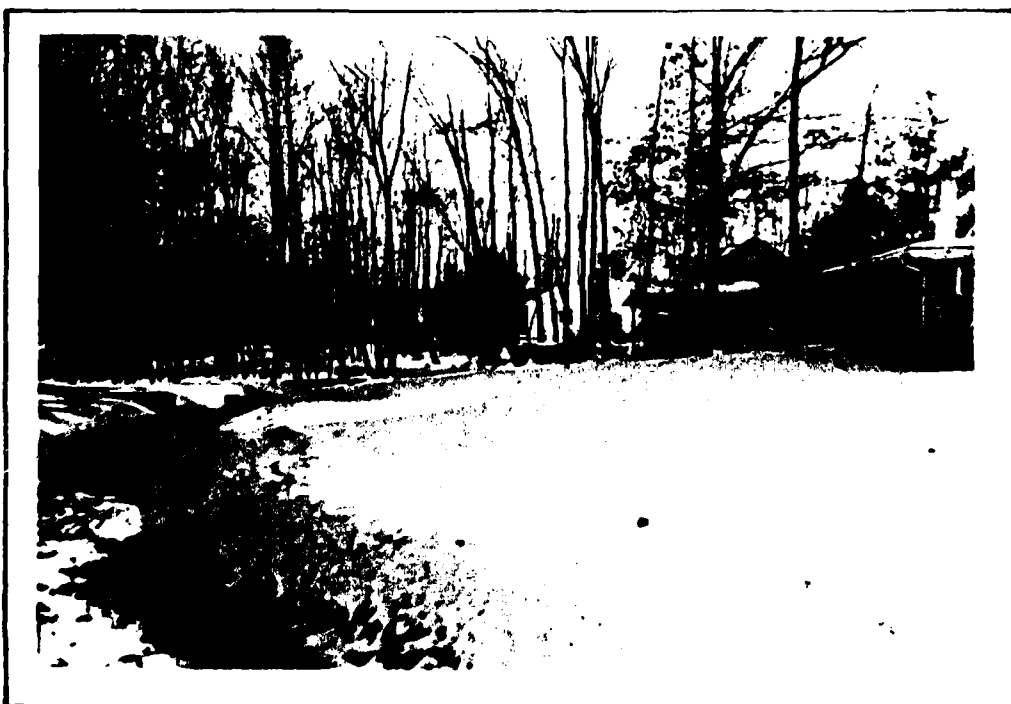
d. Hazard Classification. Five houses which would be affected by the failure of the dam are located within 1,500 feet downstream of the dam. Door sills of the dwellings are as low as five feet above the streambed. Therefore, the dam is classified as a "High" hazard structure due to the potential for the loss of more than a few lives and excessive property damage.

10. POTENTIAL DAMAGE AREA ABOUT 500 FEET DOWNSTREAM OF THE DAM.
(12/20/80)

1. A regular inspection and maintenance program should be developed and implemented.
2. A system for warning downstream residents in the event of an impending dam failure should be developed.
